State of Oregon  
Department of Forestry - Department of Revenue  
Notification Number: 2014-781-00527  
Timber Sale: Rust Rd/R.W G4468/G4915

**RE:** Shallow Landslide and Public Safety Risk Assessment  
Rust Road unit (HPU 231068), Triangle Lake watershed

South Valley  
Setting Map  
Rust Road  
18-16S-7W

Setting: G4468  
HPU: 231068  
Harv.Yr.: 2014  
FPA:

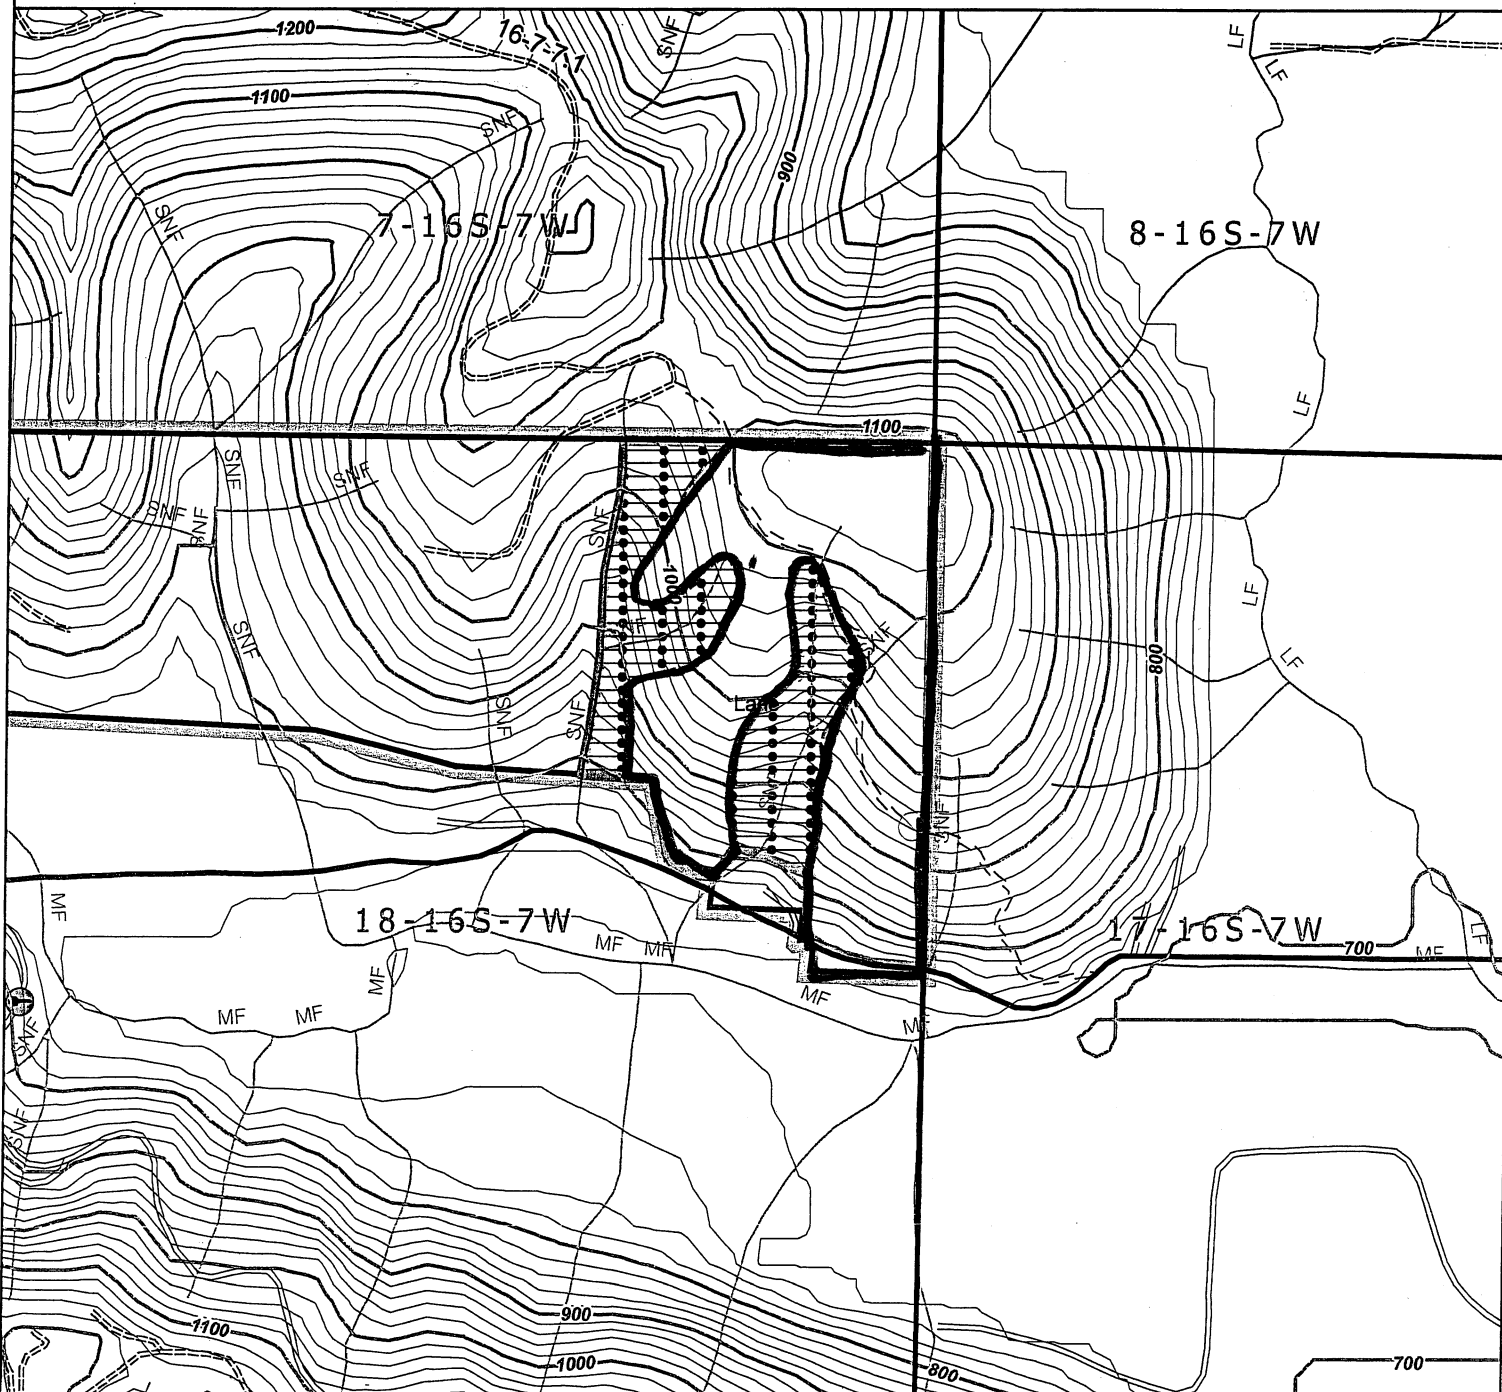
The review determined the Downslope Public-Safety Risk to be Moderate to Intermediate. To minimize the Downslope Public-Safety Risk, no harvest activity will occur in High Landslide Hazard Locations (HLHL). All HLHL have been flagged out and designated as leave tree areas. Please see attached Notification Map.

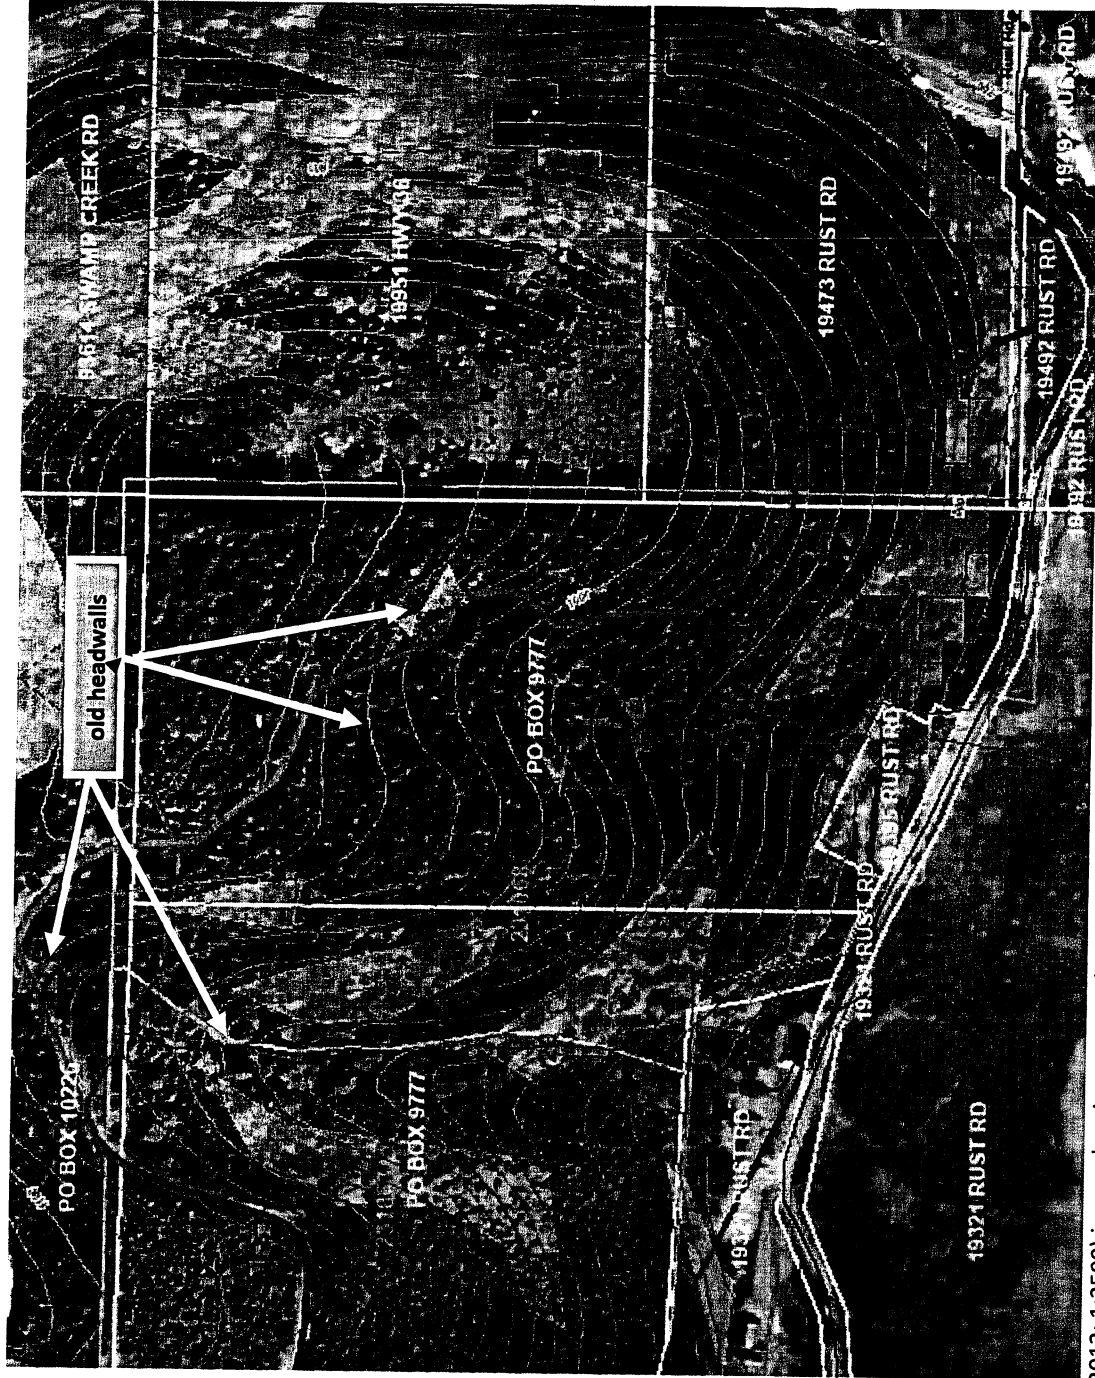
**High Landslide Hazard Locations:** High Landslide Hazard Locations (HLHL) are shown approximately as yellow and pink pixels in Figure 1 (from Weyerhaeuser RMS slope-class map; derived from USGS 10-m DEM data acquired by Weyerhaeuser; yellow pixels represent slopes with 60%-80% gradient and pink are slopes exceeding 80%). We verified gradients in the field that exceed 65% in draws and 75% on open slopes, per OAR 629-623-0100 (a,b). Note that slope classes in Figure 1 under-represent the true location and extent of steep slopes in the unit.

initiation point of the western tributary fork and coincident with the BLM 16-7-7.1 road, another located on the same drainage downslope of the road, a third and fourth located near the initiation points of the eastern tributary fork and near the BLM road (see arrows in Figure 1). These old headwalls predate the original harvest, based on presence of in-situ large stumps, and likely represent episodic failures associated with changes in groundwater flow potentially along the geologic contact between the alluvium and Tyee sandstones. More recent surficial mass movement and erosion have occurred on the face of these old features, potentially associated with root tip, groundwater flow, and channel undermining.

**Figure 1.** NAIP (2012; 1:2500) image showing proposed Rust Road harvest unit (HPU 231068; orange numbered polygon with orange numbers). Yellow pixels denote slopes with 60% to 80% gradient; pink with gradients exceeding 80% (USGS-DEM derived). Geologic units are shown with red polygons (thick lines) and lettering (Tt = Tertiary Tyee Formation turbidites; Qal = Quaternary alluvium). Magenta line shows route of the BLM 16-7-7.1 road through the unit. White polygons show property boundaries with respective addresses. Blue dots indicate approximate locations of water intake systems for downstream residences and thin red lines show [inaccurate] locations of untyped channels draining the unit. Contour interval 20 ft.

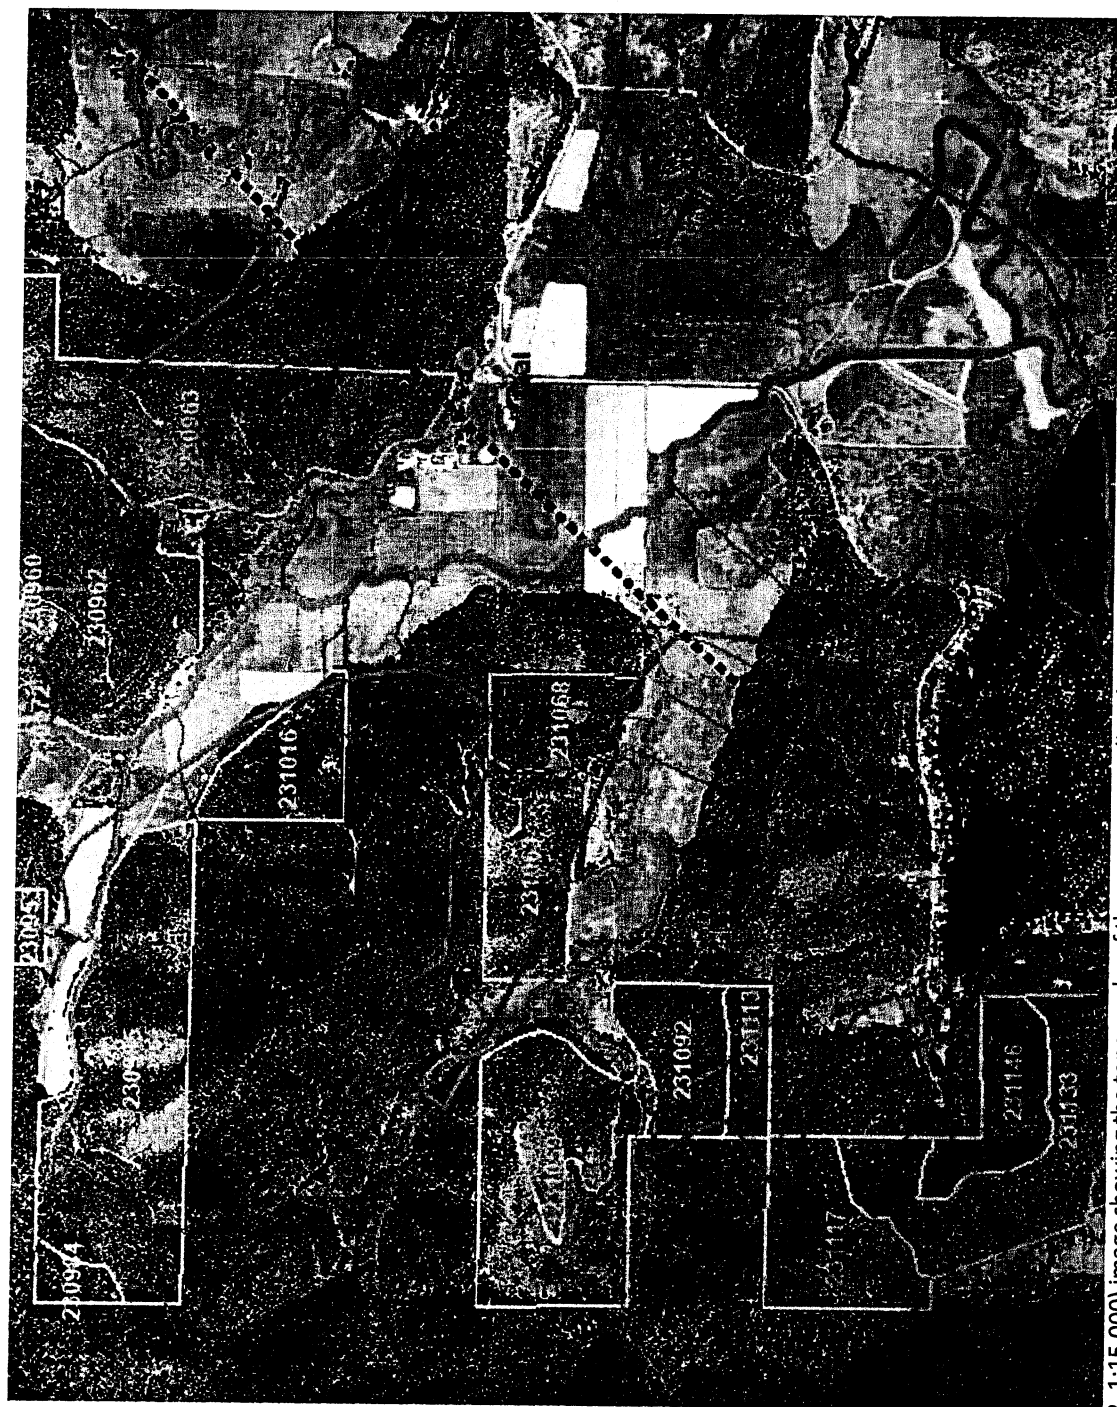
**Figure 2.** NAIP (2012, 1:15,000) image showing the topography of the area surrounding the HPU 231068 unit (center of image). The unit is underlain by Quaternary alluvium (Qal) deposited in a landslide-dammed lake that filled the upper Siuslaw drainage and created the broad, flat valleys that are now prime agricultural sites. Triangle Lake (lower center of image) is a remnant of this Pleistocene lake. Weathering and erosion have exposed underlying Tye Formation turbidites (Tt) in the NW and SE corners of the unit and surrounding areas. The black dotted line defines the axis of a large fold or trough in the bedrock layers.
